Infrared Report

Project Name

GENELCO INC

Commissioning/Testing/Controls

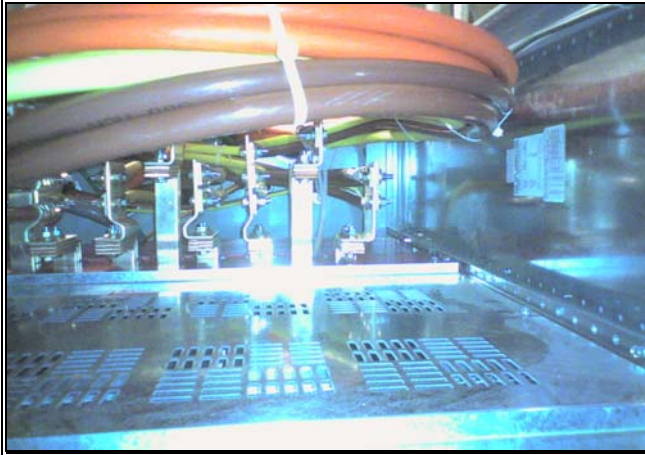
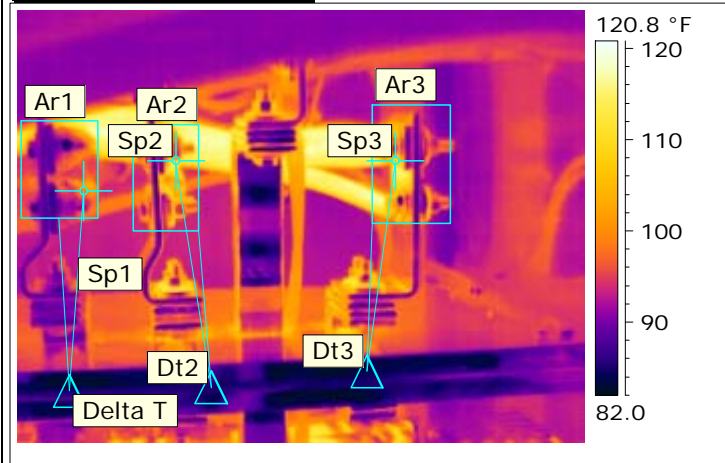
Equipment	Main SWBD 402
Component	UPS A Feeder Breaker Connections
View	Direct
Condition of Equipment	Loaded
Actual Load	564kW
Fault	No Faults Found
Recommendations	None Needed

Ar1 Max. Temperature	118.2 °F
Ar2 Max. Temperature	119.5 °F
Ar3 Max. Temperature	117.3 °F
Sp1 Temperature	98.5 °F
Sp2 Temperature	112.2 °F
Sp3 Temperature	111.2 °F
Delta T Value	19.7
Dt2 Value	7.3
Dt3 Value	6.1

No action is required at this time.

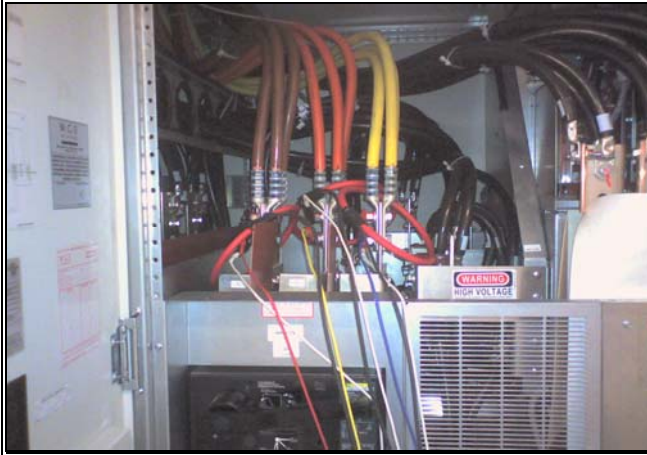
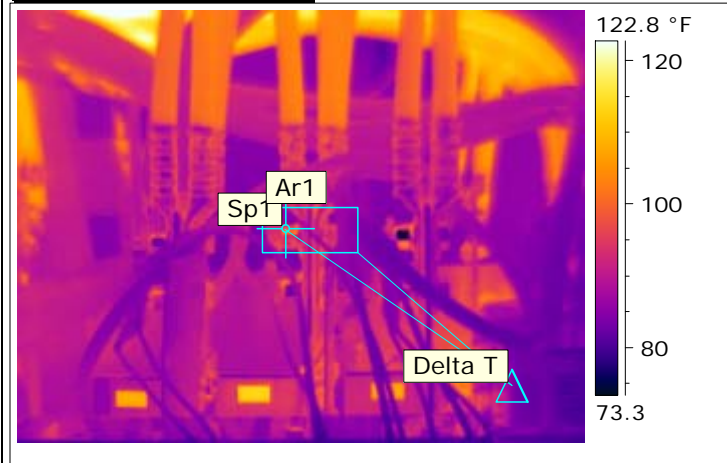
Equipment	UPS A
Component	Input Connections & Breaker (Q1)
View	Direct
Condition of Equipment	Loaded
Actual Load	564kW
Fault	No Faults Found
Recommendations	None Needed

Ar1 Max. Temperature	104.0 °F
Sp1 Temperature	100.8 °F
Delta T Value	3.2

No action is required at this time.

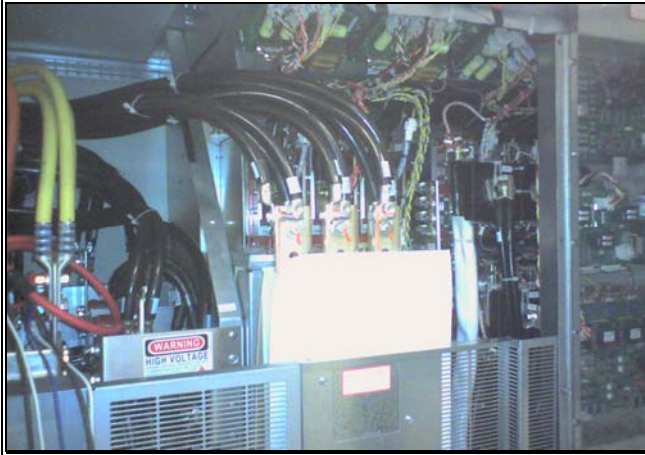
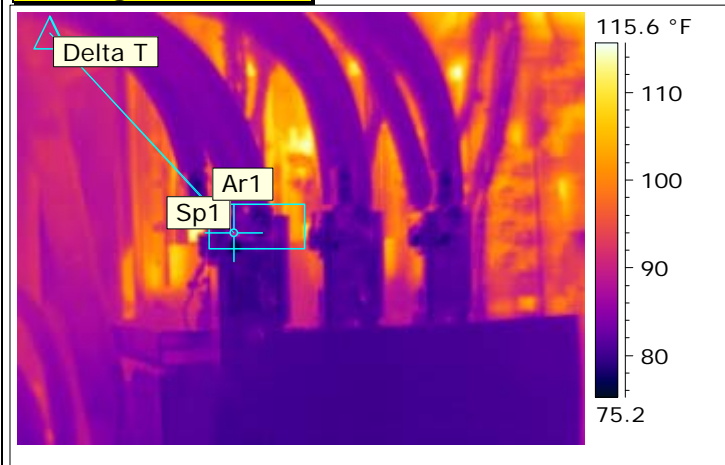
Equipment	UPS A
Component	Output Buss Connections
View	Direct
Condition of Equipment	Loaded
Actual Load	564kW
Fault	No Faults Found
Recommendations	None Needed

Ar1 Max. Temperature	112.5 °F
Sp1 Temperature	90.8 °F
Delta T Value	21.7

No action is required at this time.

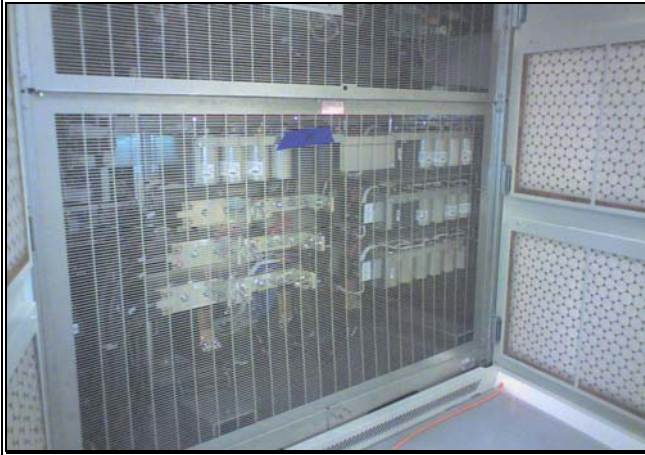
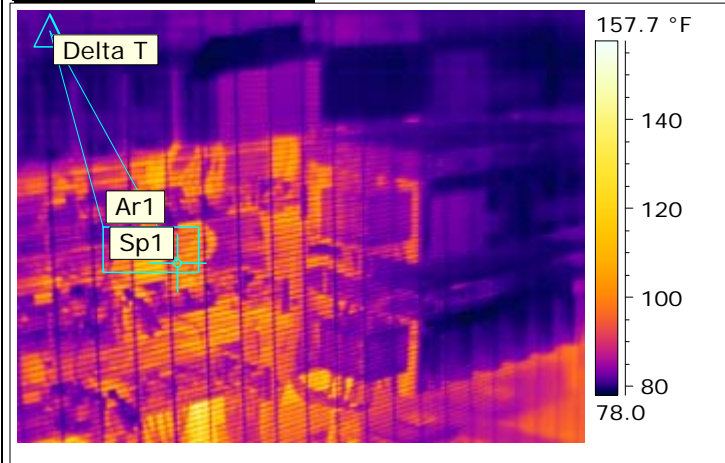
Equipment	UPS A
Component	Caps & Buss Connections
View	Direct
Condition of Equipment	Loaded
Actual Load	564kW
Fault	No Faults Found
Recommendations	None Needed

Ar1 Max. Temperature	125.6 °F
Sp1 Temperature	104.9 °F
Delta T Value	20.7

No action is required at this time.

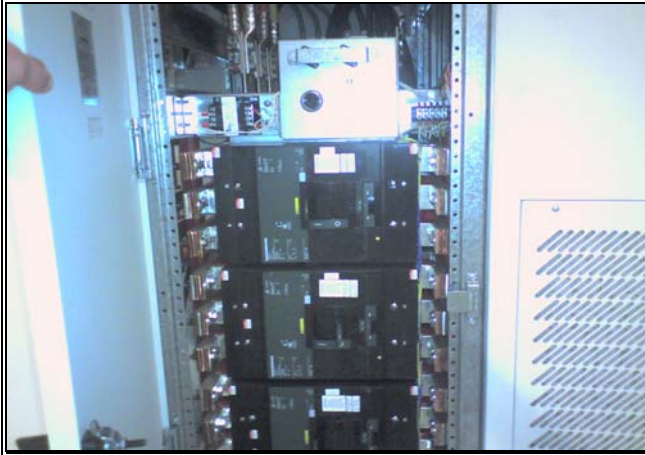
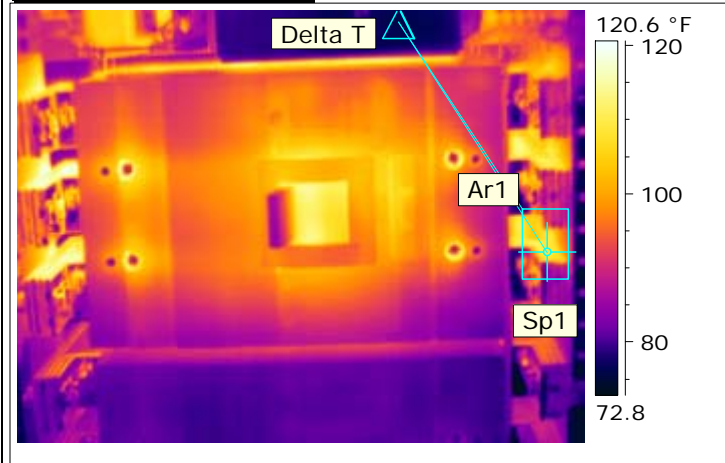
Equipment	UPS A
Component	Q5N Output Breaker Connections
View	Direct
Condition of Equipment	Loaded
Actual Load	564kW
Fault	No Faults Found
Recommendations	None Needed

Ar1 Max. Temperature	113.3 °F
Sp1 Temperature	108.9 °F
Delta T Value	4.4

No action is required at this time.

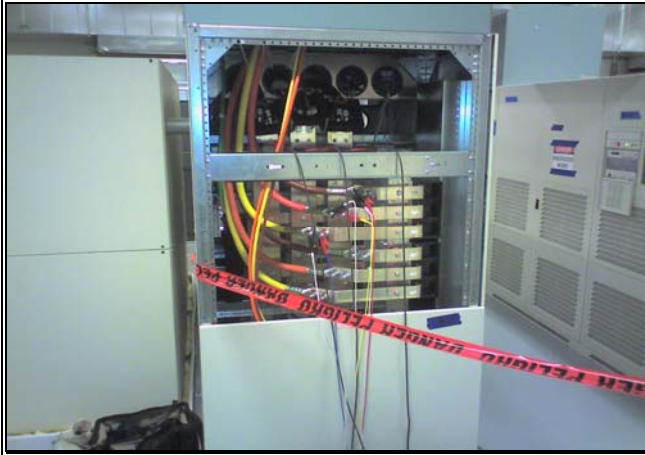
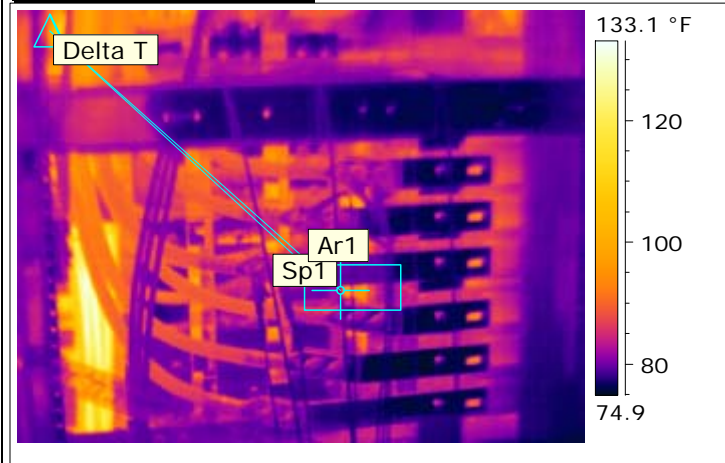
Equipment	UPS A
Component	Output Connections to PDUs
View	Direct
Condition of Equipment	Loaded
Actual Load	281kW Each
Fault	No Faults Found
Recommendations	None Needed

Ar1 Max. Temperature	101.7 °F
Sp1 Temperature	89.2 °F
Delta T Value	12.4

No action is required at this time.

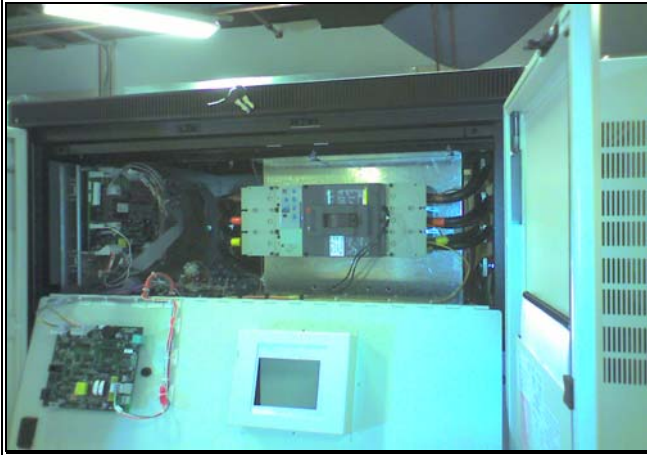
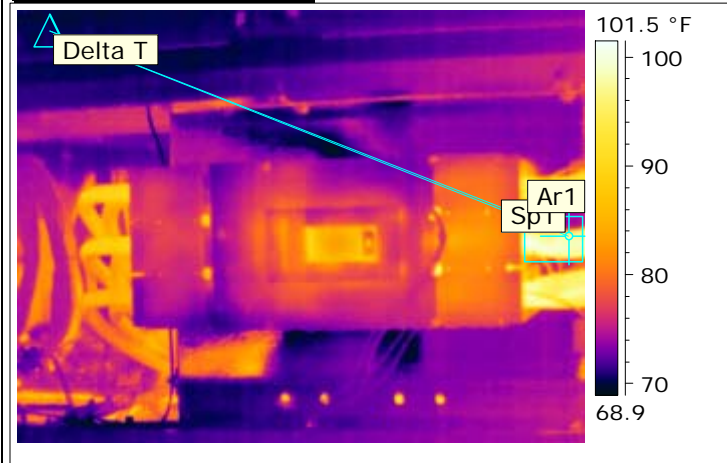
Equipment	PDU 402A-1
Component	Main Input Breaker Connections
View	Direct
Condition of Equipment	Loaded
Actual Load	281kW
Fault	No Faults Found
Recommendations	None Needed

Ar1 Max. Temperature	101.8 °F
Sp1 Temperature	97.8 °F
Delta T Value	4.1

No action is required at this time.

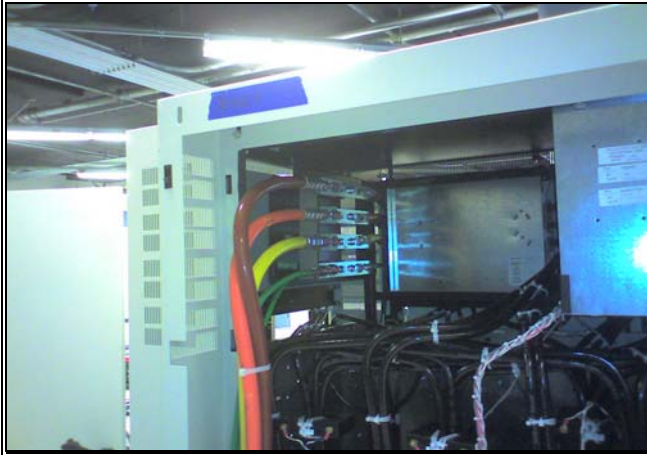
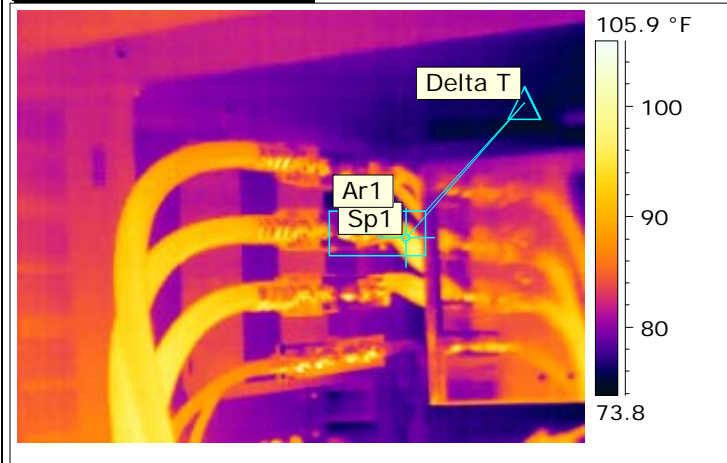
Equipment	PDU 402A-1
Component	Main Inout Feeder Connections
View	Direct
Condition of Equipment	Loaded
Actual Load	281kW
Fault	No Faults Found
Recommendations	None Needed

Ar1 Max. Temperature	98.9 °F
Sp1 Temperature	94.6 °F
Delta T Value	4.2

No action is required at this time.

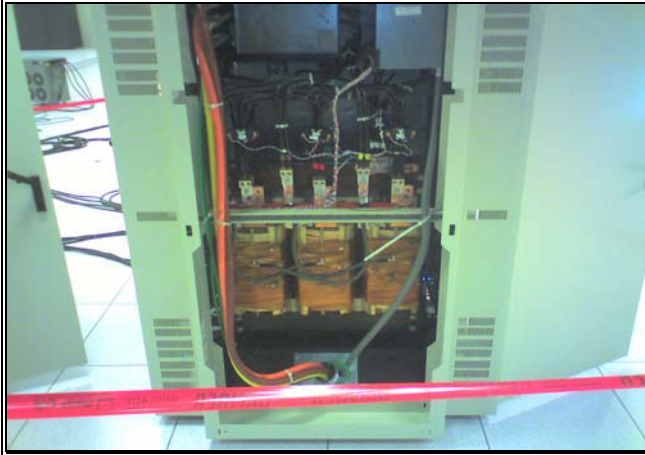
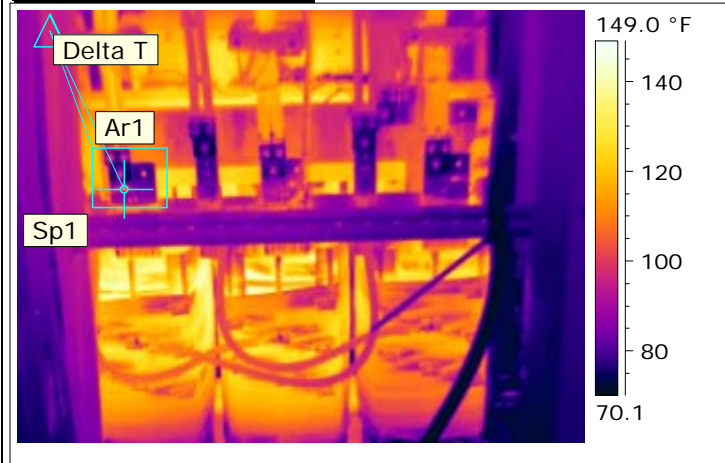
Equipment	PDU 402A-1
Component	Transformer Connections
View	Direct
Condition of Equipment	Loaded
Actual Load	281kW
Fault	No Faults Found
Recommendations	None Needed

Ar1 Max. Temperature	127.9 °F
Sp1 Temperature	106.9 °F
Delta T Value	21.0

No action is required at this time.

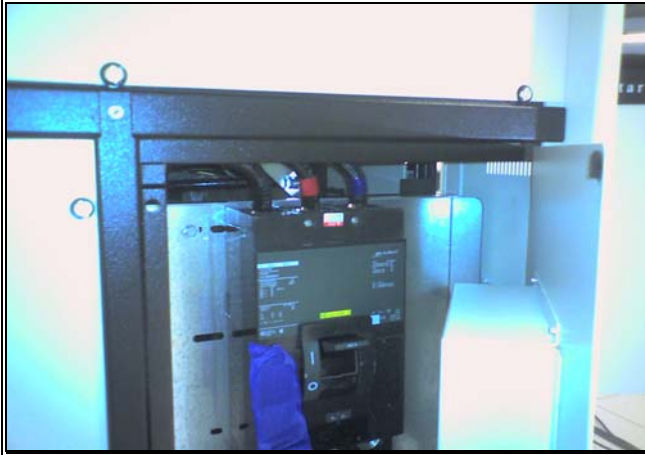
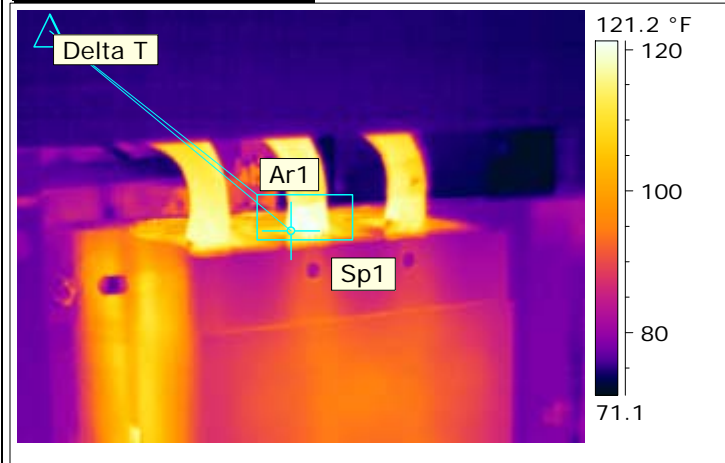
Equipment	PDU 402A-1
Component	Subfeed Breaker 1 Connections
View	Direct
Condition of Equipment	Loaded
Actual Load	60kW
Fault	No Faults Found
Recommendations	None Needed

Ar1 Max. Temperature	121.4 °F
Sp1 Temperature	111.5 °F
Delta T Value	9.9

No action is required at this time.

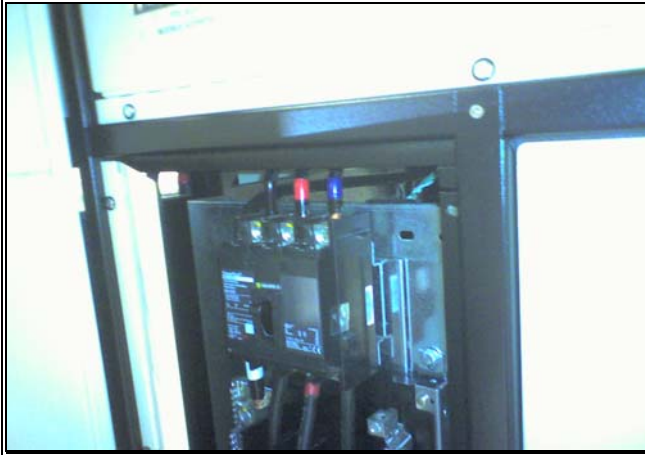
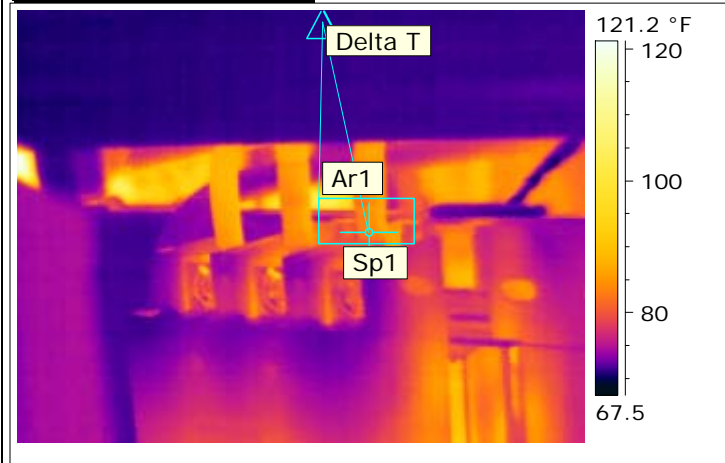
Equipment	PDU 402A-1
Component	Subfeed Breaker 2 Connections
View	Direct
Condition of Equipment	Loaded
Actual Load	60kW
Fault	No Faults Found
Recommendations	None Needed

Ar1 Max. Temperature	103.6 °F
Sp1 Temperature	83.3 °F
Delta T Value	20.2

No action is required at this time.

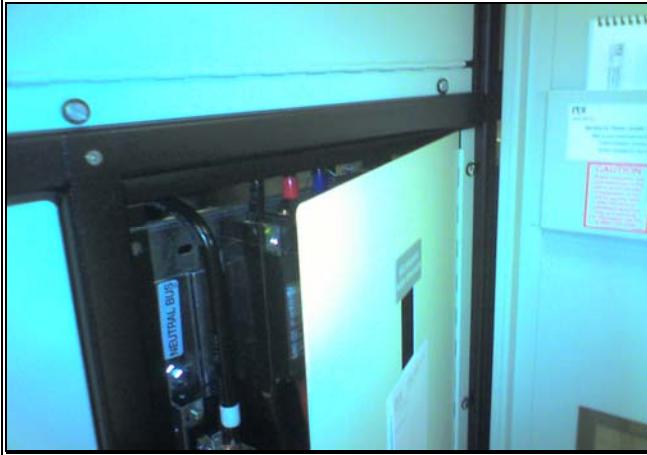
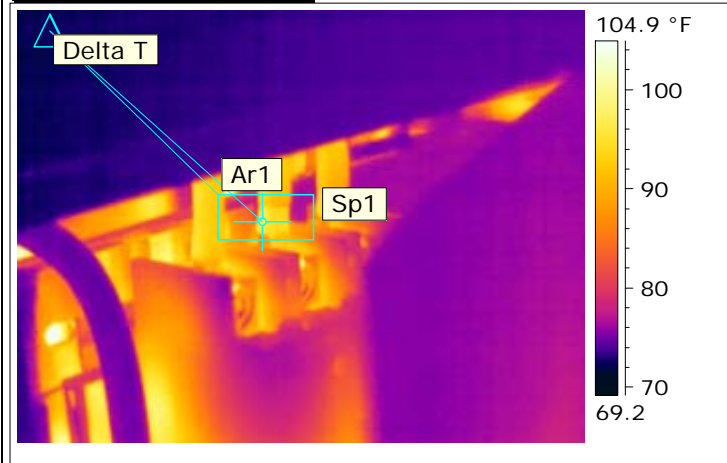
Equipment	PDU 402A-1
Component	Subfeed Breaker 3 Connections
View	Direct
Condition of Equipment	Loaded
Actual Load	60kW
Fault	No Faults Found
Recommendations	None Needed

Ar1 Max. Temperature	97.4 °F
Sp1 Temperature	96.5 °F
Delta T Value	0.9

No action is required at this time.

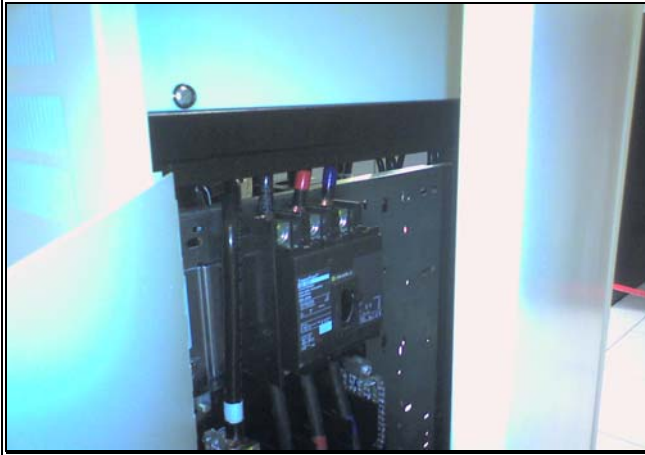
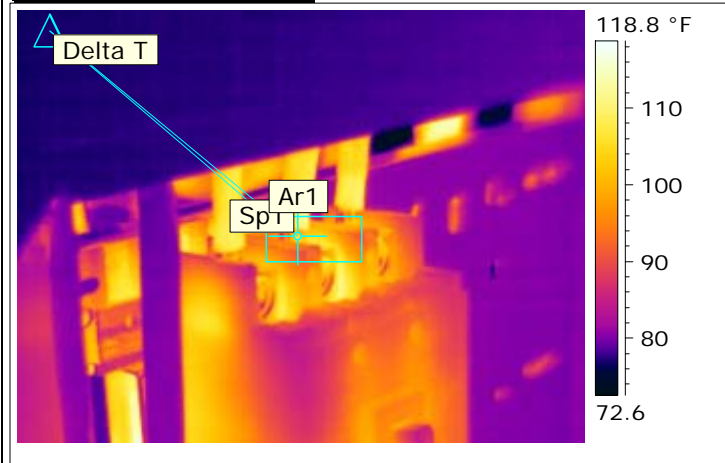
Equipment	PDU 402A-1
Component	Subfeed Breaker 4 Connections
View	Direct
Condition of Equipment	Loaded
Actual Load	100kW
Fault	No Faults Found
Recommendations	None Needed

Ar1 Max. Temperature	112.4 °F
Sp1 Temperature	108.7 °F
Delta T Value	3.7

No action is required at this time.

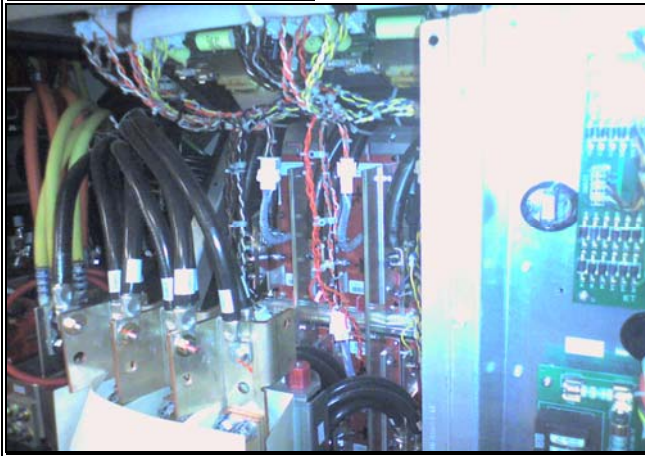
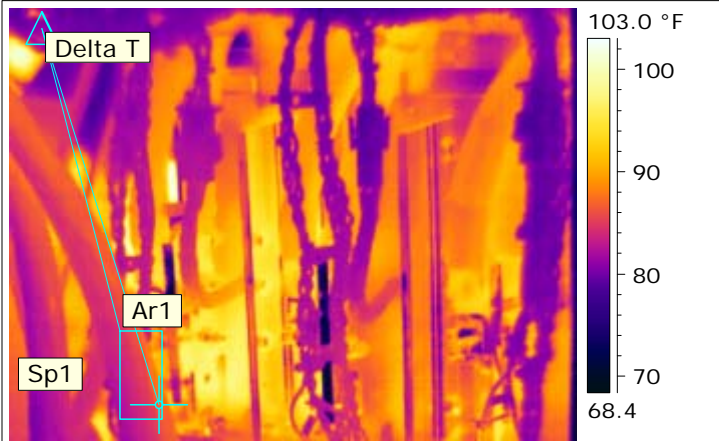
Equipment	UPS A
Component	Static Feed Connections
View	Direct
Condition of Equipment	Loaded
Actual Load	564kW
Fault	No Faults Found
Recommendations	None Needed

Ar1 Max. Temperature	93.5 °F
Sp1 Temperature	87.0 °F
Delta T Value	6.5

No action is required at this time.

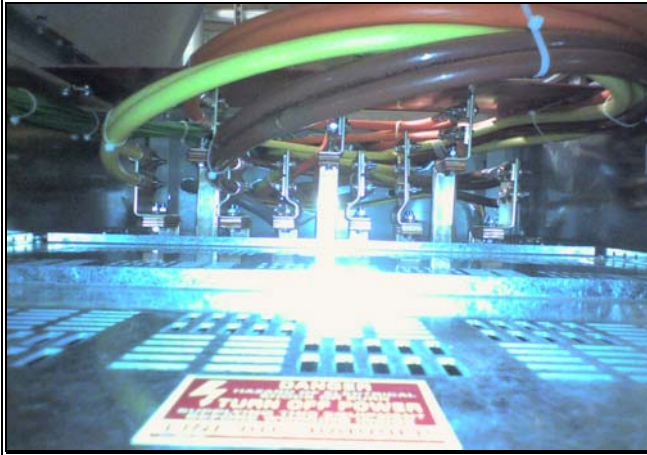
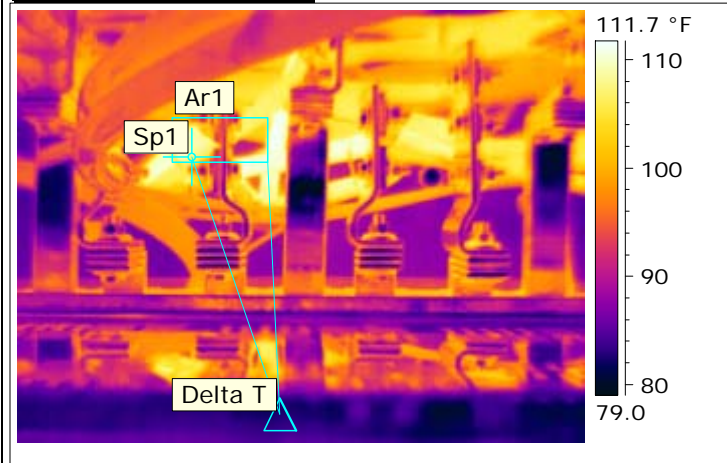
Equipment	Main SWBD 402
Component	Maint Bypass Feeder Breaker Connections
View	Direct
Condition of Equipment	Loaded
Actual Load	564kW
Fault	No Faults Found
Recommendations	None Needed

Ar1 Max. Temperature	110.7 °F
Sp1 Temperature	106.9 °F
Delta T Value	3.8

No action is required at this time.

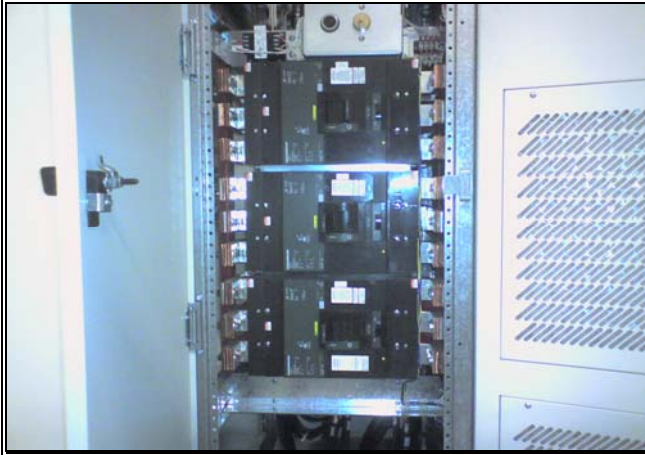
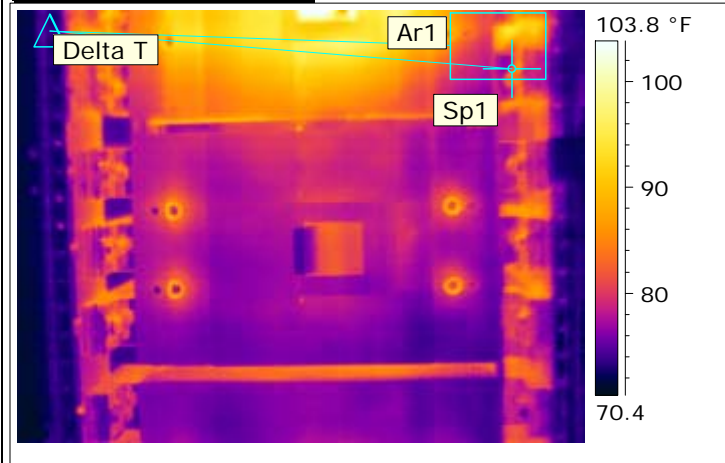
Equipment	UPS A
Component	Maintenance Bypass Breaker
View	Direct
Condition of Equipment	Loaded
Actual Load	564kW
Fault	No Faults Found
Recommendations	None Needed

Ar1 Max. Temperature	95.1 °F
Sp1 Temperature	84.3 °F
Delta T Value	10.8

No action is required at this time.

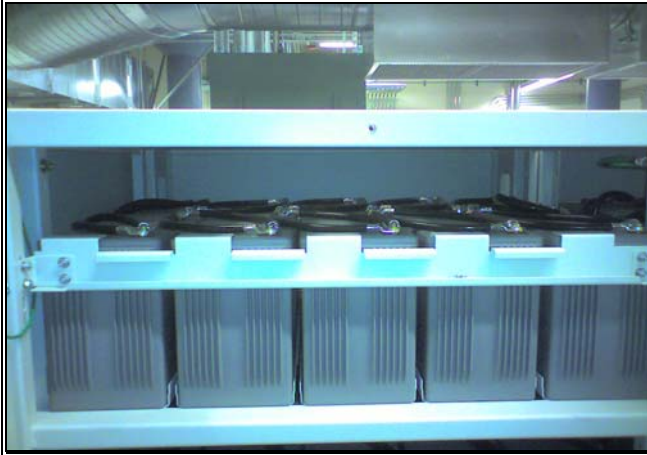
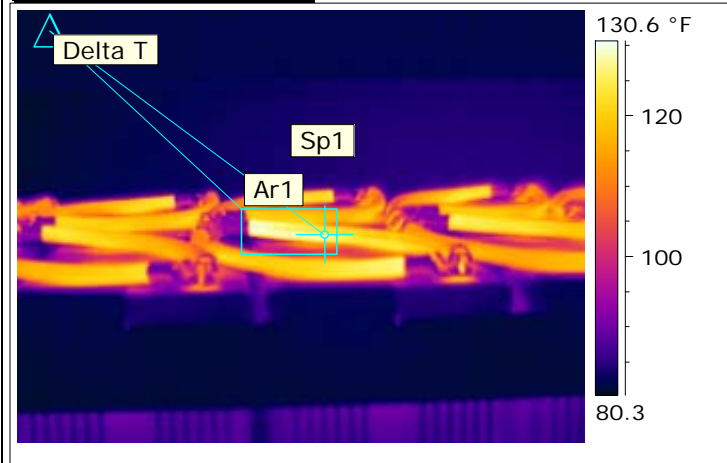
Equipment	UPS A String 1
Component	Battery Disconnect
View	Direct
Condition of Equipment	Loaded
Actual Load	564kW
Fault	No Faults Found
Recommendations	None Needed

Ar1 Max. Temperature	130.8 °F
Sp1 Temperature	127.6 °F
Delta T Value	3.3

No action is required at this time.
